White paper

Accuracy check for infusion pumps using IDA 4 plus

Written by Ichiro Suzuki. Sendai Medical Center, Sendai, Japan

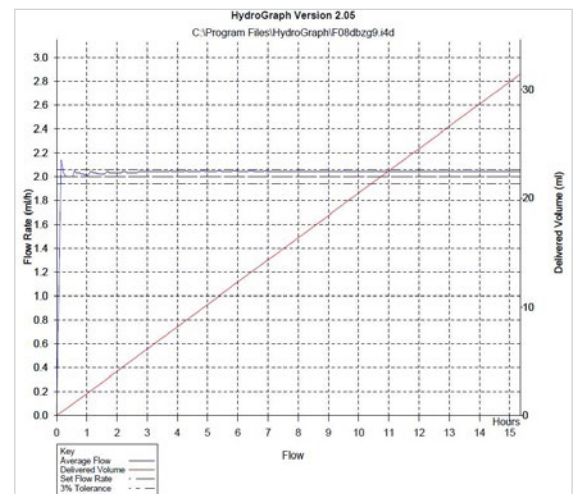
Figure 4. Incorrect pump flow rate found after more than 12 hours of an inspection re-flow.

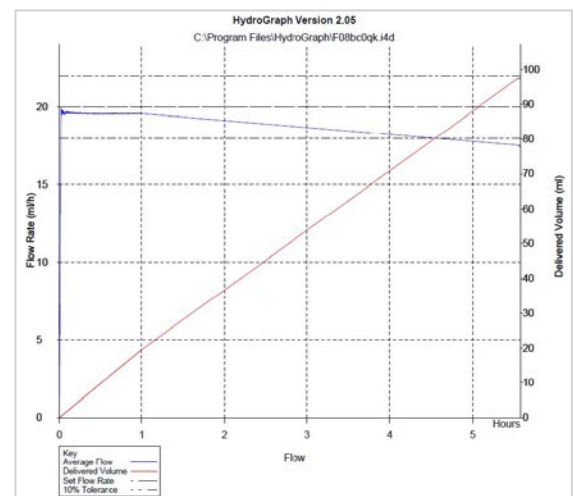
Figure 6. Infusion pumps, flow anomaly after 4 hours

One infusion pump had abnormal flow rates four hours after the start of measurement. Similarly, one syringe pump had incorrect flow rates three hours after the start of measurement, suggesting it may be impossible to ensure reliable accuracy control by approximately one hour of measurement. Accuracy checks may require measurement over three to four hours as is performed in our hospital. On the other hand, four clinical engineers in our hospital are engaged in multiple clinical operations, and any of them cannot be exclusively committed to inspection duties. If the inspection takes one hour, they cannot concentrate on the other clinical operations. A Fluke Biomedical IDA 4 Plus infusion device analyzer, which allows several hours of measurement without supervision, sets them free from attendance for the flow rate measurement and enables them to perform other clinical operations instead. Using IDA 4 Plus, which allows accuracy check for four infusion pumps in parallel at once, accuracy checks can be performed for up to 16 pumps per day in our hospital. The flow rate inspection is associated with the following problems. First, inspection of pumps must be carried out with due attention to the status of use because the pumps cannot be available to use during several hours of inspection. Secondly, the results of flow rate inspection are currently recorded and stored on a paper basis. Given a huge amount of printouts to be output in the future, it will be more desirable to record and store the results electronically rather than on a paper basis. Currently in Japan, however, regulatory audit of hospitals requires paper-based disclosure of data, warranting future studies on the validity of electronic recording and storing.

Since short duration of flow rate inspection has problems with accuracy control, at least three hours of flow rate inspection is desirable. Introduction of Fluke Biomedical IDA 4 Plus infusion device analyzers has led to an increase in the failure detection rate of infusion and syringe pumps and an improvement in safety. It may also contribute to more efficient operations by the clinical engineers. IDA 4 Plus is expected to reduce the duration of inspection and improve productivity because it ensures the inspection of flow rate with high accuracy and allows simultaneous measurements at multiple channels and electronic recording and storing with minimum clinical engineers attendance. The “oven” is set to a temperature between 28 °C and 40 °C. The Skin Temperature Sensor is plugged into the temperature control module and the temperature sensing element is placed in the “oven”. The difference in temperature between the “oven” and the sensor should not exceed 0.3 °C.

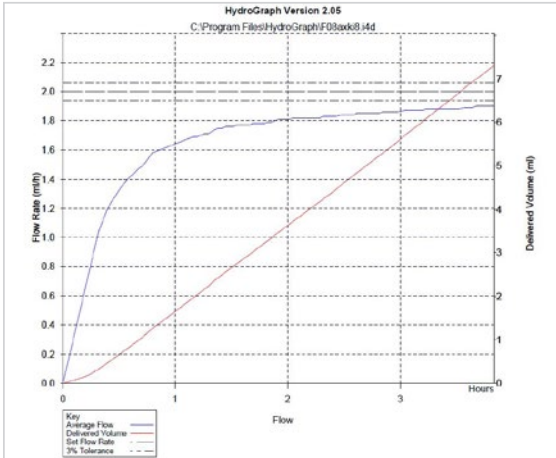
Figure 7. Syringe, flow anomaly

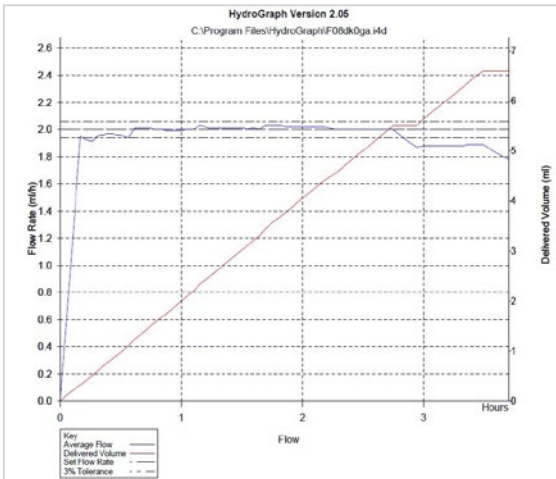
Figure 8. Syringe, flow anomaly after 3 hours
