White paper

Accuracy check for infusion pumps using IDA 4 plus

Written by Ichiro Suzuki. Sendai Medical Center, Sendai, Japan

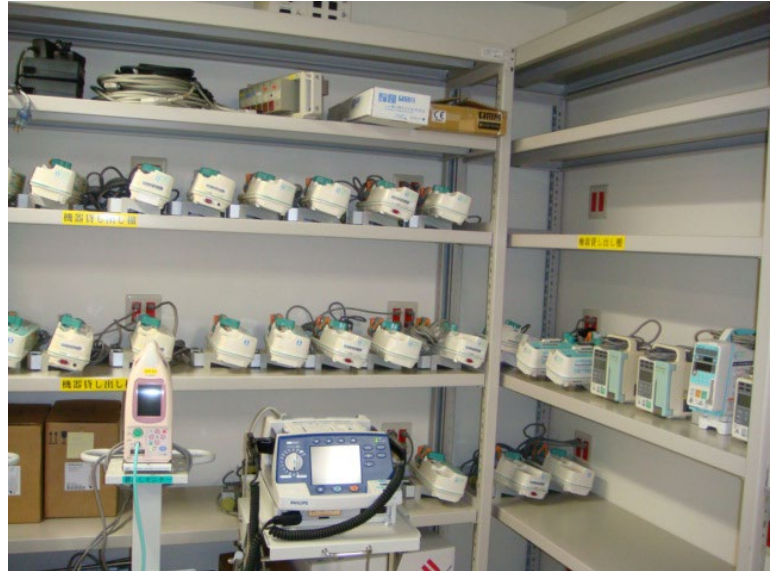
Figure 1. Centralized storage syringe infusion pumps

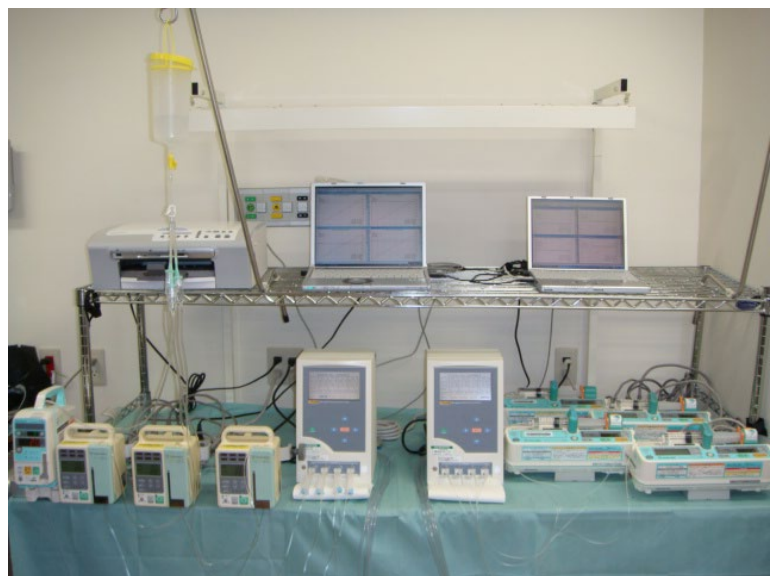
Figure 2.

In our hospital, accuracy checks are performed every month for all infusion and syringe pumps, in principle, using two Fluke Biomedical IDA 4 Plus infusion device analyzers and distilled water (Fig. 2). For accuracy checks, the flow rate is measured over three to four hours for each pump with a flow accuracy of 20 mL ± 10 % for infusion pumps and 2 mL ± 3 % for syringe pumps (Fig. 3). For any infusion pump with incorrect values, the test is repeated over 12 hours or more to confirm the flow rate (Fig. 4). Upon completion of the inspection, a flow rate inspection report is printed out and filed in the equipment control register. All inspected infusion and syringe pumps are marked with a sticker showing inspection completion in monthly different colors and are then available for rent.

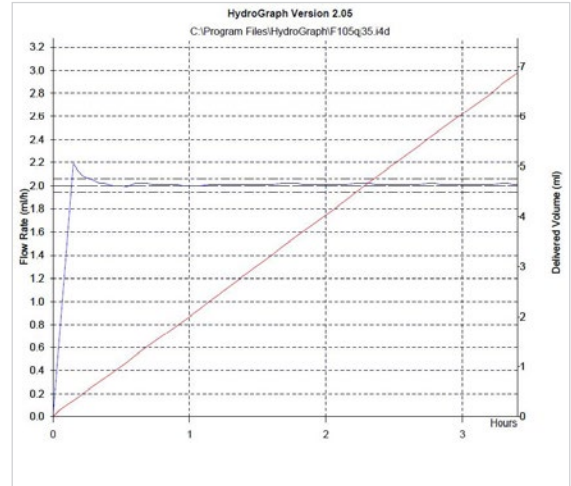
Figure 3. Normal data

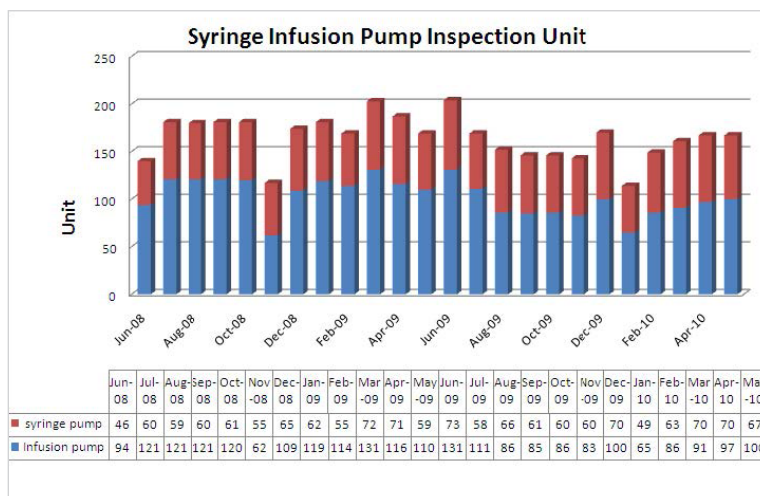
The number of infusion and syringe pumps inspected every month is shown in Fig. 5. During the period, a total of 2,459 infusion pumps were inspected, with a monthly mean of 102 ± 9 pumps. In this period, incorrect flow rates were observed with 4 infusion pumps, resulting in a failure detection rate of 0.16 % relative to the total number of pumps inspected (hereinafter referred to as the failure detection rate) and a failure rate of 2.9 % relative to the number of pumps possessed (hereinafter referred to as the failure rate). During the period, a total of 1,492 syringe pumps were inspected, with a monthly mean of 62 ± 7 pumps. In this period, abnormal flow rates were observed with seven syringe pumps, resulting in a failure detection rate of 0.46 % and a failure rate of 8.4 % (Table 1). In one infusion pump with abnormal flow rates, the flow rate was stable until one hour after the start of measurement, but thereafter began to decrease gradually, deviating from a normal range four hours after the start of measurement (Fig. 6). In some syringe pumps, abnormal flow rates were observed immediately after the start of measurement (Fig. 7) or three hours after the start of measurement (Fig. 8).

Figure 5. Syringe infusion pump inspection unit
